4781 Race St

This spreadsheet performs screening level calculations to estimate the effect of peeling leaded paint on the average concentration of lead in yard soil  
**4781 Race Street**

## LBP Assessment Results

SITE NAME: VASQUEZ BOULEVARD AND I-70

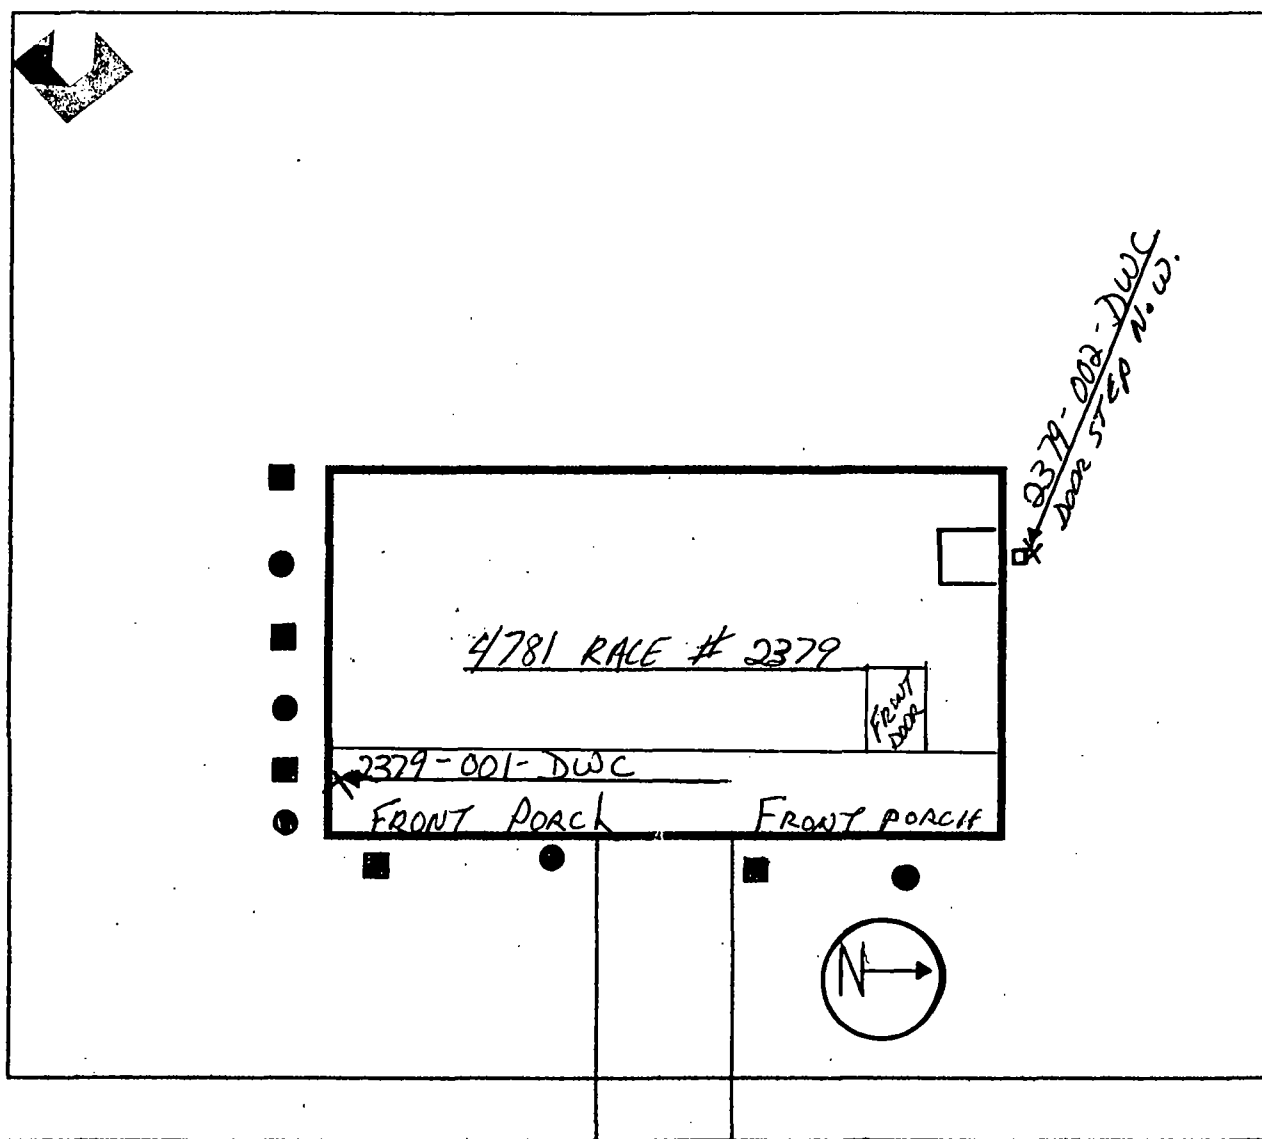
- 1) 2379 - 001 - DWc 11:40 hours 05-03-06
- 2) 2379 - 002 - DWc 11:50 hours 05-03-06
- 3) 2379 - 001 - SCC ● 11:38 hours 05-03-06 one foot offset
- 4) 2379 - 002 - SCC ■ 11:52 hours 05-03-06 one foot offset
- 5)
- 6)

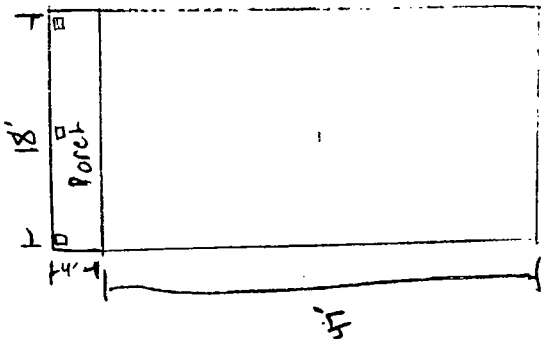
neighbors House (XRF 22.2 lead) 40' ext North wall

$$(47+6)(18+6) - 63 \times 11 = 1272 \text{ (2)}$$

$$\text{Area of Porch} = 444 \text{ (2)}$$

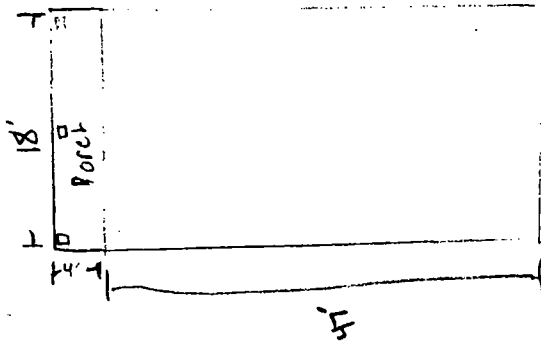
neighbors House (XRF 23.2 lead) 40' ex North wall

$$(47+6)(18+6) - 53 \times 4 = 1272$$

$$\text{Area of Porch} = 400 \square$$
